HISTORIC RESOURCES INVENTORY FORM

DENTIFICATION	
1. BUILDING NAME: Common:	Historic: Hayes-Chaffee House
2. TOWN/CITY: Middletown VILLAGE:	COUNTY: Middlesex
3. STREET & NUMBER (and/or location): 27 Please	int Street

Hayes-Chaffee House

27 Pleasant Street, Middletown, CT 06457

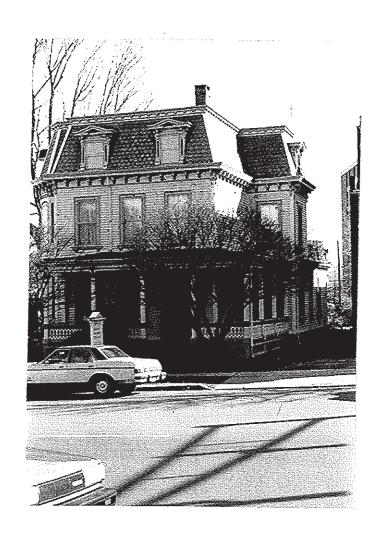
as cubical form, slate mansard roof and ped	imented dormer windows. Decora	tive brackets
support the eaves. On the east wall is a tr	wo and one half story bay with	a decorative
porthole dormer and a one story gallery.		
The Hayes-Chaffee House is representative	of the architectural taste pre-	valent during
the South Green's development as a prime res	sidential area in the 1870's.	
Olle Podoli di coli pi dovorobmono do di bi min		reflex and promote more interesting and a section in the more of the profession of the configuration of the config
